**Flood Control Project Maintenance
Levee Inspections**

2016 Channel Summary Report

Fairfield Suisun Sewer District

Levee Inspection Report By Mile - Channel 2016

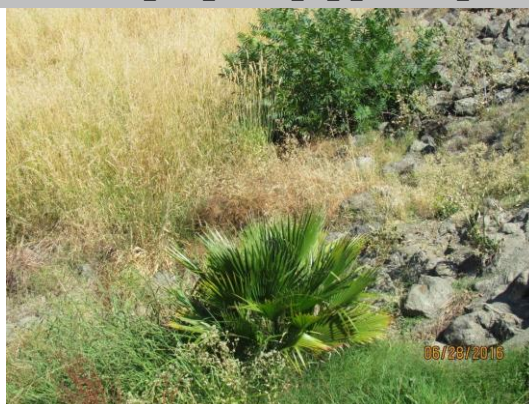
Photo 2 of 3 : CH_2016_NA0035_15_1_20160629_00048.jpg

Suggest removal of volunteer palm tree. Summer 2016.

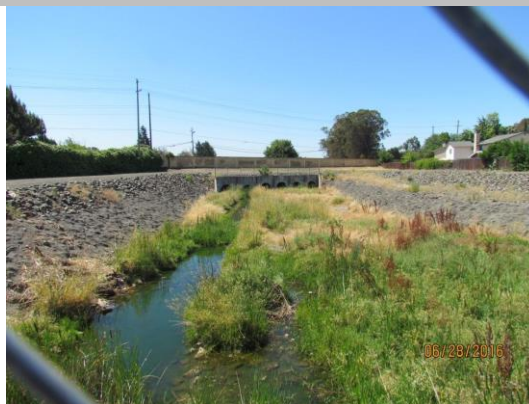
Photo 1 of 2 : CH_2016_NA0035_15_46_20160629_00057.jpg

Rating **	A	Issue No.	46	GPS Lat/Long
Issue Type +	Ma	Location *		38.259272 °
Category	Rivers, Channels & Designated Flood			-122.017533 °
Item	Vegetation & Obstructions			
DWR ID	DWR_NA0035_15_c_2012_46			
Action/Comments				
Inspector Comments: This area is the same as upstream Railroad Avenue. I recommend the removal of the volunteer palm trees.

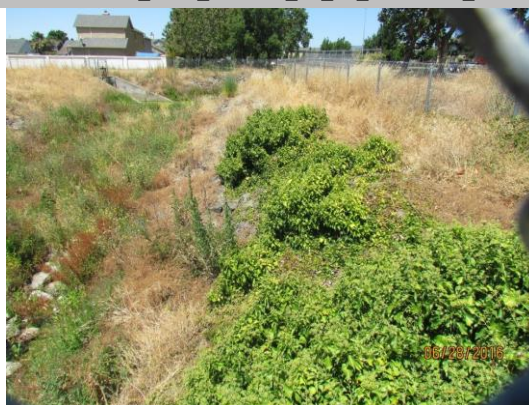
Photo 1 of 3 : CH_2016_NA0035_15_64_20160629_00060.jpg

View of the vegetation on the revetment on the left bank looking upstream. Summer 2016.

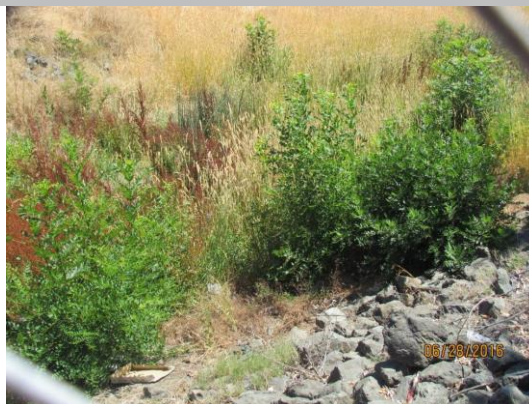
Photo 2 of 3 : CH_2016_NA0035_15_66_20160629_00062.jpg

Suggest removal of woody vegetation near the right bank revetment.

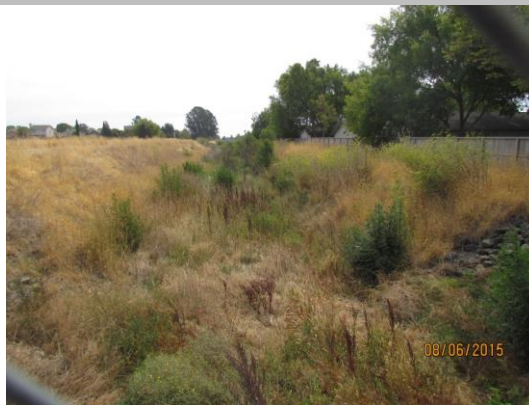
Photo 3 of 3 : CH_2016_NA0035_15_66_20160620_00030.jpg

Looking downstream from Sunset Ave. Some woody vegetation has been removed. Summer 2015.

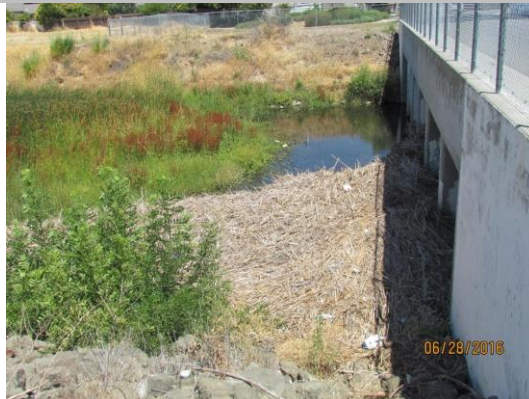
Photo 1 of 1 : CH_2016_NA0035_15_75_20160629_00064.jpg

Inspector Comments: Trash, debris, excavations, structures, or other obstructions present, or inappropriate activities that will not inhibit project operations and maintenance or emergency operations were observed.

Debris pile is stacking up in the upstream part of the channel on Blossom Rd. Summer 2016.

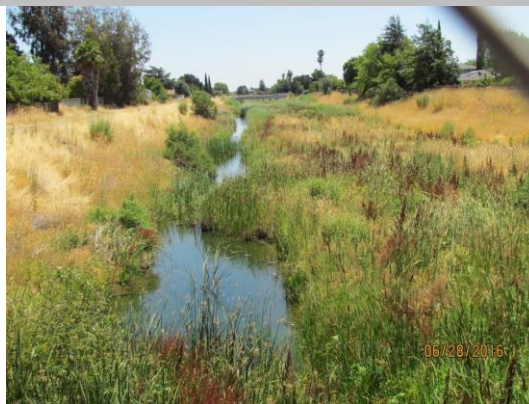
Photo 1 of 2 : CH_2016_NA0035_15_76_20160629_00065.jpg

View of the channel looking downstream from Blossom Rd. Woody vegetation has been removed. Summer 2016.

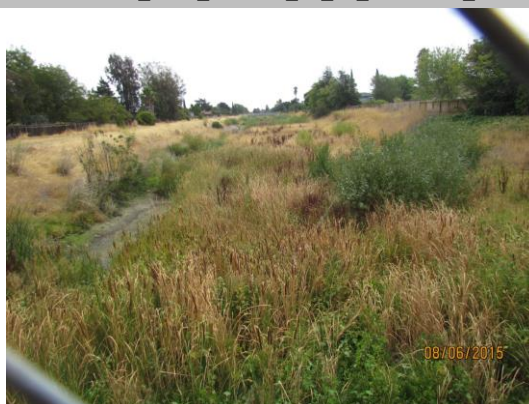
Photo 2 of 2 : CH_2016_NA0035_15_76_20160620_00038.jpg

Looking downstream from Blossom Rd. Suggest removal of woody vegetation. Summer 2015.

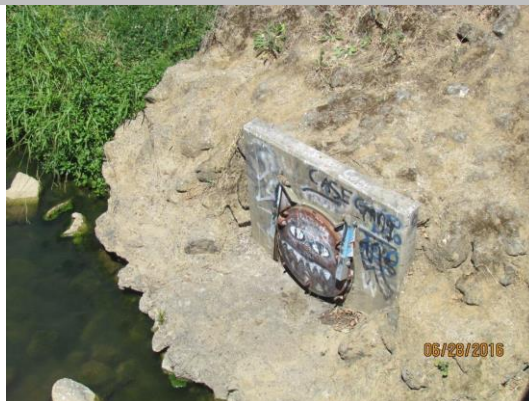
Photo 1 of 1 : CH_2016_NA0035_17_24_20160629_00060.jpg

Inspector Comments: Flap gate has been replaced.

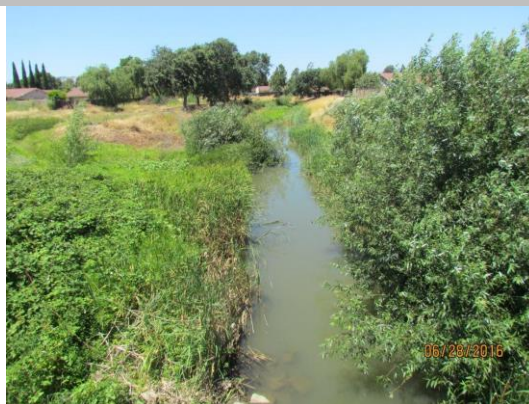
Photo 1 of 2 : CH_2016_NA0035_17_61_20160629_00045.jpg

View of the channel looking upstream from Highway 12. Suggest trimming of trees. Summer 2016.

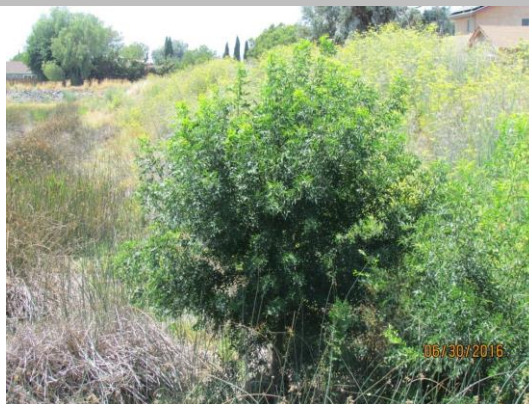
Photo 1 of 3 : CH_2016_NA0035_14_16_20160707_00023.jpg

Remove woody vegetation from the creek. Summer 2016.

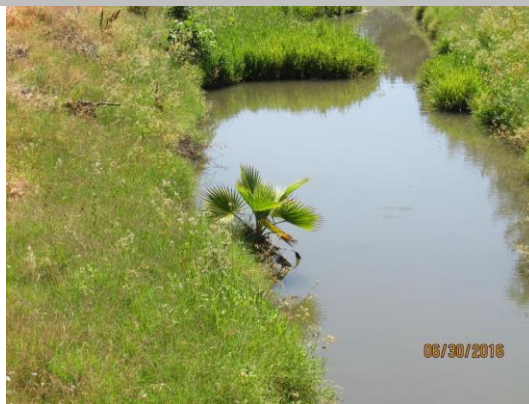
Photo 1 of 3 : CH_2016_NA0035_16_26_20160707_00026.jpg

Remove small palm trees in the diversion. Summer 2016.

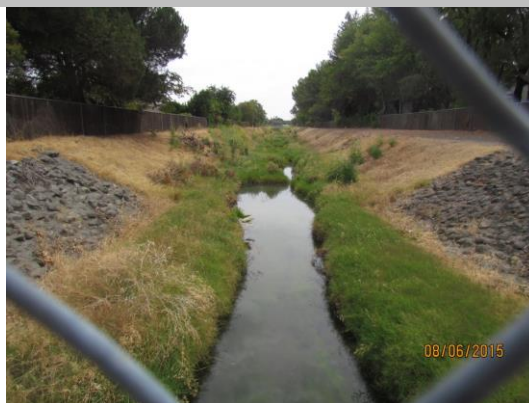
Photo 3 of 3 : CH_2016_NA0035_16_26_20160620_00012.jpg

Looking downstream from Dover Ave. Woody vegetation has been removed. Summer 2015.
